# Investigation of Corrosion on Inland Petroleum Distribution System Aluminum Pipe Grooved Ends Caused by Rubber Gaskets

by Howard E. Horner

ARL-TR-1449

August 1997

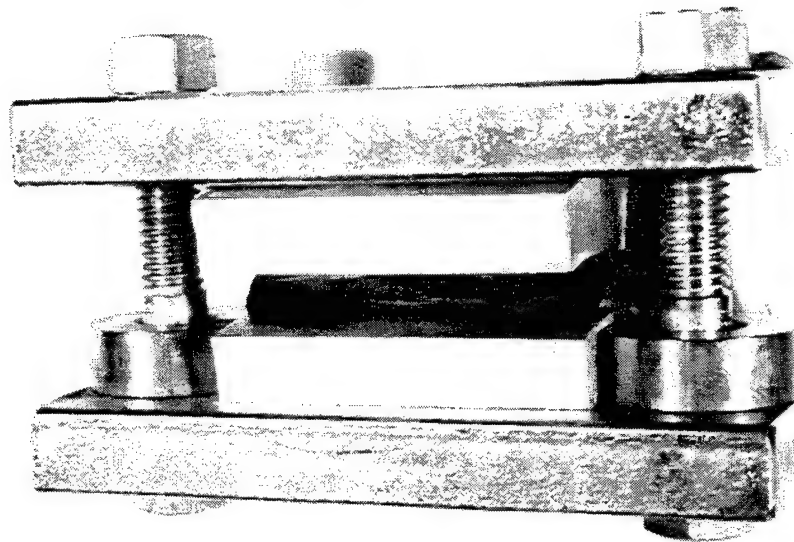
Figure 3. View of the cross-sectional rubber specimen placed between two small, curved aluminum pipe pieces in the stainless steel clamp for the accelerated corrosion test (actual size). This setup would simulate the rubber gasket in compression inside the IPDS snap-joint coupling in the clamped position. The compressed seal lips of the gasket is in contact with the bare surface of the curved IPDS pipe pieces.

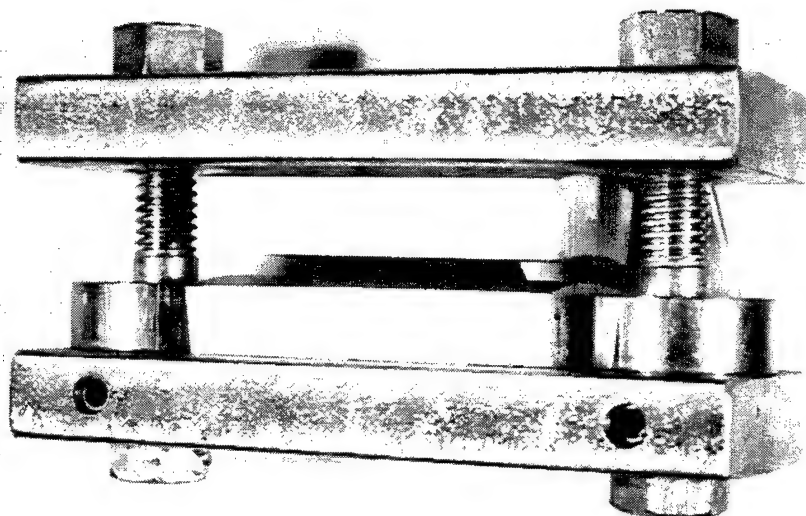
Figure 4. View of the flat rubber specimen placed between two small, curved aluminum pipe pieces in the stainless steel clamp for the accelerated corrosion test (actual size). The specimen is in contact with both bare aluminum surfaces.

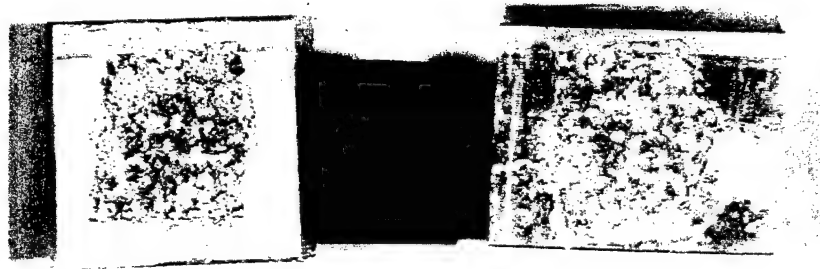
The first corrosion tests were performed on two rubber specimens cut from a used IPDS epichlorohydrin rubber half sample from Fort Lee. One of them had its original surface left on, and the other specimen had its outer skin sliced off to expose new surfaces. Figure 5 shows a typical example of the corrosion on the bare aluminum surfaces after the corrosion test. Significant amounts of chlorine and lead were detected by x-ray analysis in the white corrosion products formed on the machined surface of the aluminum piece. The mode of corrosion on the aluminum pieces was similar to the type of corrosion that was observed on the corroded aluminum pipe grooved end.

Figure 5. View of corroded area on the bare metal surfaces in contact with the small rubber sample (middle) after the 2-week experimental accelerated corrosion test in the oven (160° F and 90% humidity) (slightly larger than actual size). The aluminum piece on the right has the original machined convex surface, which did have some corrosion, but not as extensive as seen in Figure 1.

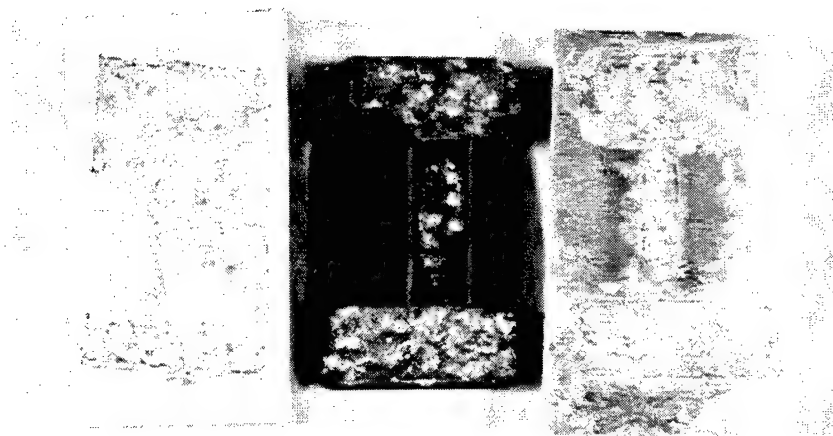
The results of the corrosion tests by two new one-piece gasket rubber specimens on the bare aluminum surfaces are shown in Figures 8–11. The type of the corrosion attack on the aluminum in contact with the reformulated epichlorohydrin rubber specimens was the same that was observed on the bare aluminum pipe grooved ends in contact with the two-piece epichlorohydrin rubber gaskets inside the IPDS snap-joint couplings on the assembled IPDS unit in the field at Fort Lee. Significant amounts of chlorine and lead were detected by x-ray analysis in the white corrosion products formed on the bare aluminum surface in contact with the reformulated epichlorohydrin rubber specimen. This confirmed the conclusion made in the earlier corrosion investigation that chlorine, as one of the ingredients in the rubber material, played a part in the corrosion of aluminum. The extent of corrosion observed on corroded surfaces of the small aluminum pipe pieces in the corrosion test was also superficial with a few small, shallow surface

Figure 7. View of the corroded areas on the bare metal surfaces that were in contact with the reformulated epichlorohydrin rubber specimen (black) after the 2-week experimental accelerated corrosion test (actual size). The rubber specimen is shown with its underside and the reinforcing rib in the upright position. The concave bare surface of the left aluminum pipe piece was in contact with the top side of the rubber specimen, whereas the convex and bare ground surface of the right aluminum piece was in contact with the seal lips and the reinforcing rib on the underside of the rubber specimen. Note the corroded areas of the white corrosion products outlining the shape of the rubber specimen in direct contact with the bare surfaces of both aluminum pieces.
